A1	Trouble-shooting program	
-----------	--------------------------	--

3. Electrical terminal diagram, BMW active check control unit

6. Trouble-shooting according to customer complaints (fault symptoms)

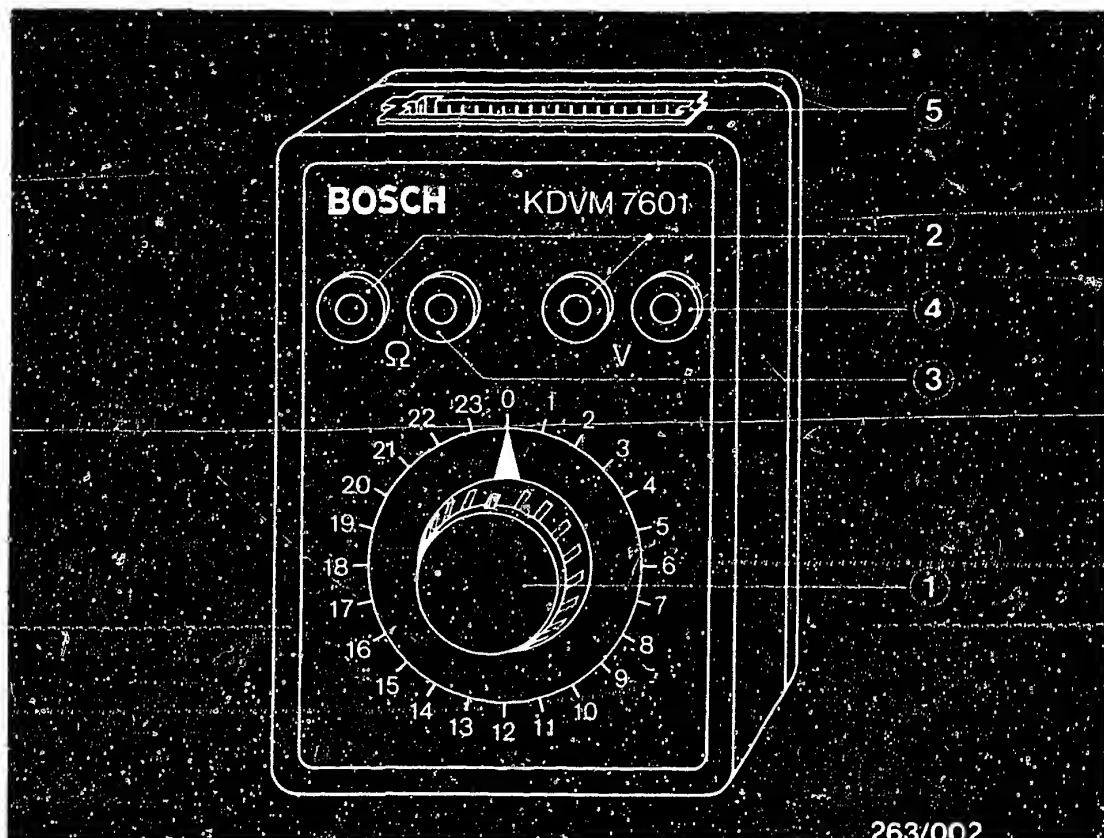
263/002

- 1 = Program selector switch
- 2 = Test jacks for connection to vehicle ground and ohmmeter/voltmeter
- 3 = Test jack, positive connection for ohmmeter
- 4 = Test jack, positive connection for voltmeter
- 5 = Socket for wiring harness plug

Connect test adapter inside vehicle instead of active check control unit. Ignition lock position at P.
Connect black jacks to vehicle ground using test lead.

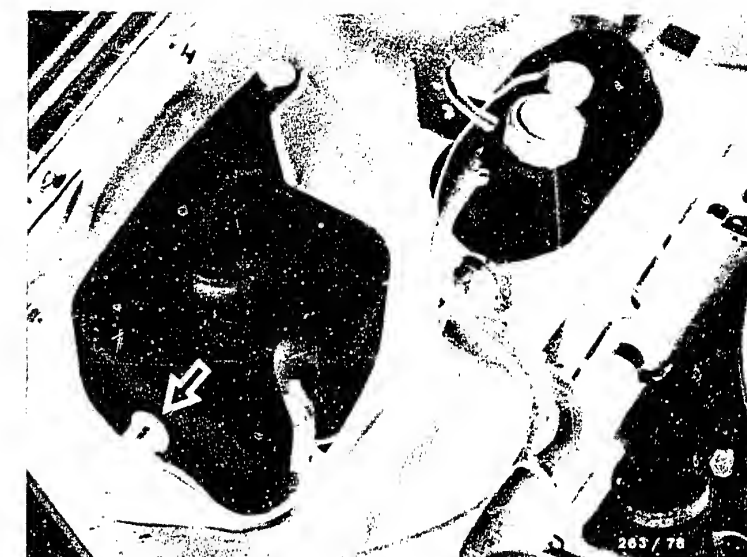
In engine compartment to the right
as viewed in direction of travel,
at front of washer-fluid reservoir
(see arrow in upper illustration).

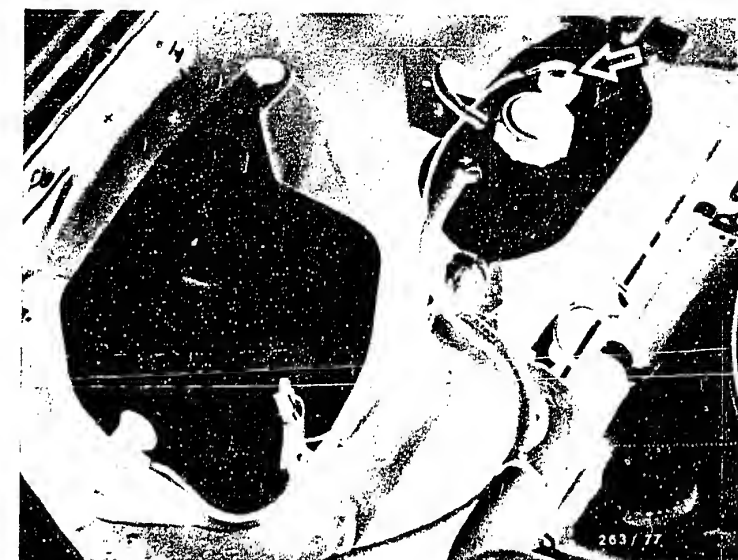
3 Series:

Cooling-water sensor is located in direction of travel (on the right in 3 Series, on left in 5 Series) in engine compartment on expansion tank. (Arrow, 3 Series)
